**EXAMPLES OF TOTARA SAPWOOD
RESISTING ATTACK BY THE COMMON
HOUSEHOLD WOOD BORER (*ANOBIUM
PUNCTATUM*)**

A Report Prepared by Paul Quinlan for Tāne's Tree Trust

31st January 2017

A report prepared on behalf of the Northland Totara Working Group.

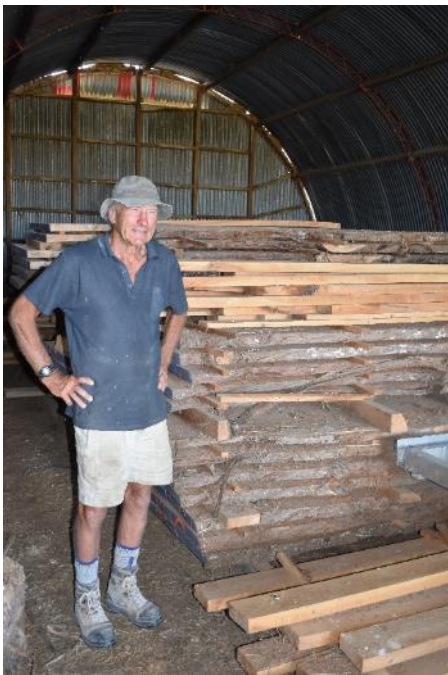
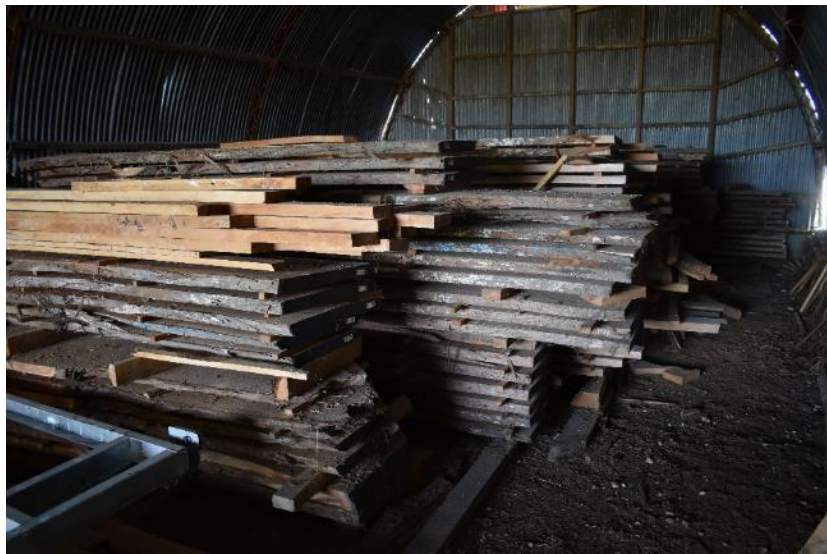
Figures: 1 & 2 – Geff Cookson standing beside the tōtara timber stored for the last 7 ½ years in his half-round barn (with one open end).

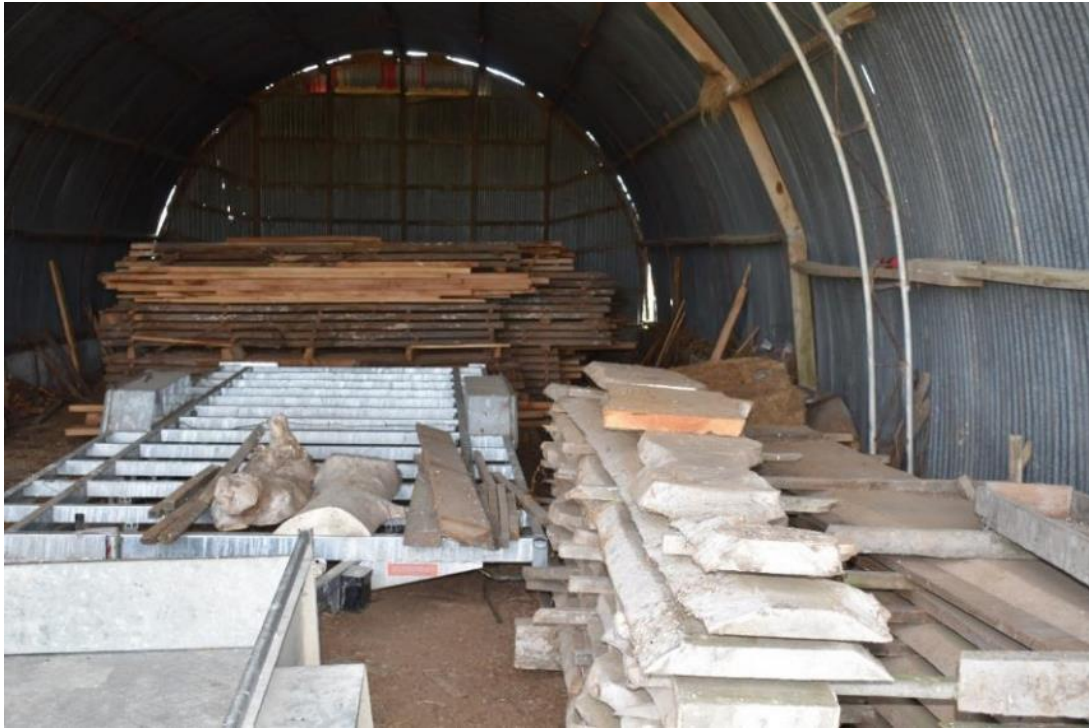
Figure: 3 – Totara slab and sawn boards stored in-fillet at the back of the shed. Slabs of kauri (grey-coloured) stored on right-hand side of the shed in foreground.

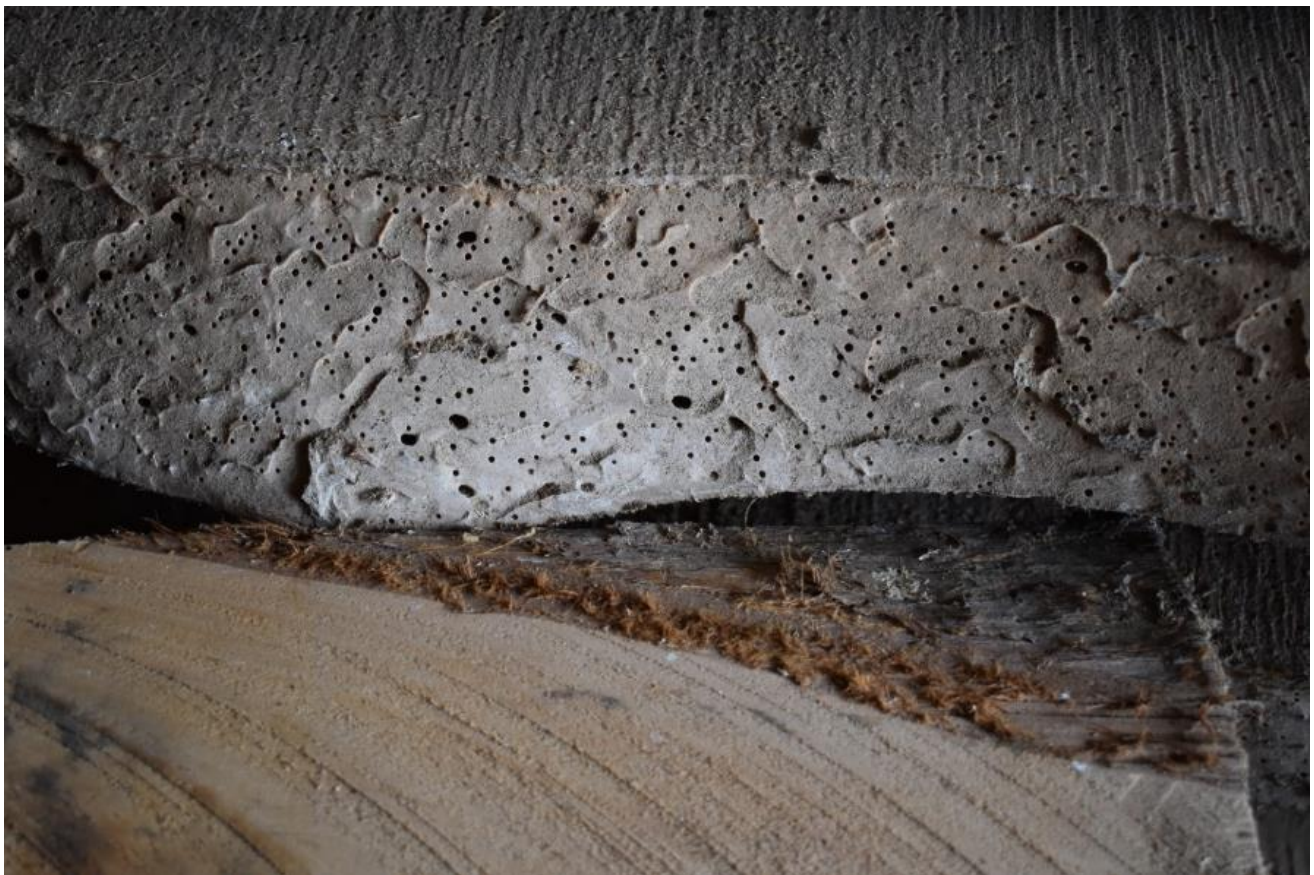
Figure: 4 – An example of kauri slab (in the top half of the photo) with sapwood riddled with the common household borer (small round holes) and the two-tooth longhorn borer (larger elliptical holes), in contrast a board of tōtara sapwood with the bark on it (in lower half of photo), without any sign of borer attack, despite being stored in close proximity to the kauri for over 7 ½ years.

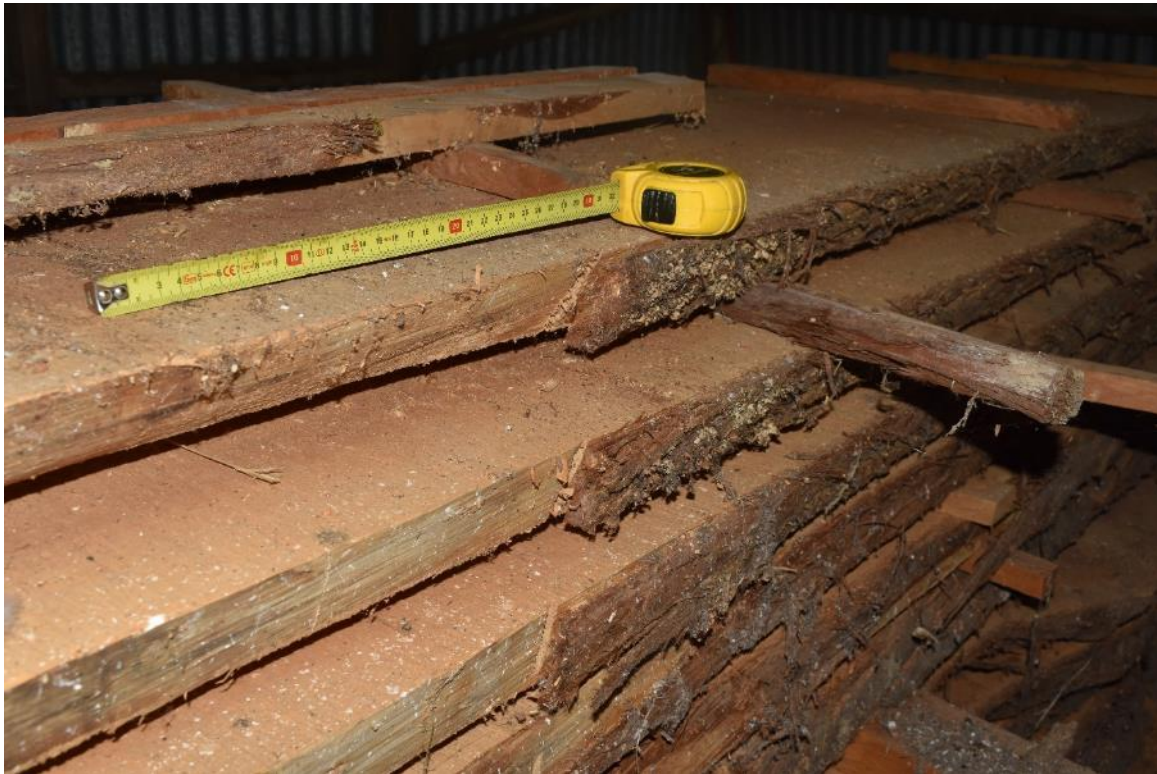
An inspection on the 18th January 2017, revealed no single observation of borer attack on any of the tōtara. This example clearly demonstrates tōtara timber, even tōtara sapwood timber, showing resistance to borer (See figures; 3- 5 below).

Figure: 5 – No evidence of borer damage was observed on any of the tōtara slabs or sawn lumber stored for over 7 ½ years in the same shed as the kauri slabs that were infested with borer.

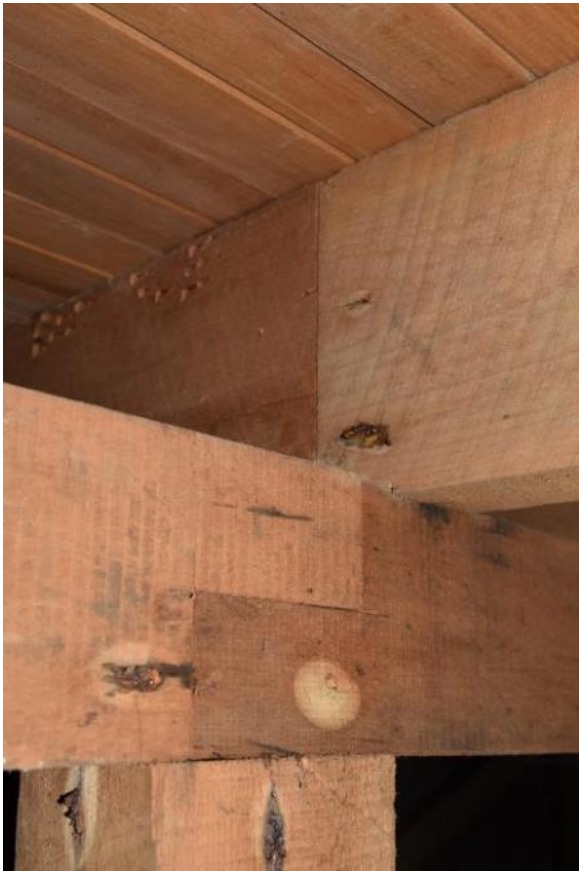
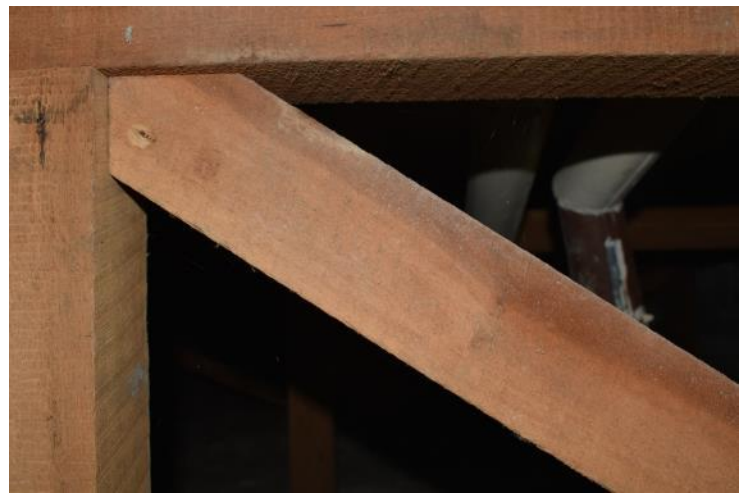
As part of this investigation, an inspection of the subfloor framing was made on the 17th January 2017. This found that although the nails and wire had mostly rusted out, the timber was in excellent condition. The only single timber defect observed was a small incidence of what is presumed to be dry-rot on an angle brace between two joists of the older house. The affected area is approximately 18cm long, 8cm wide, and 3 cm deep. It does not appear to be proportionally large enough to compromise the structural service of the timber member. No other timber defects, or incidence of borer attack, were observed in the untreated subfloor framing of either house. The untreated tōtara timber has provided excellent structural service in the subfloor framing of both houses for well over 50 years (51 & 63 years respectively).

From the careful inspection of the subfloor timber members, it appears that the builders have selected timber that is largely heartwood timber for the purpose. Some ‘coloured-grade’ timber was also observed, which is presumed to indicate pieces of timber that include a transition between heartwood and sapwood (See figures: 6-8). However, only two examples were observed that could be confidently identified as definitely comprising sapwood. One involved bark encasement (See figure: 8), the other was obvious wane (a proportion of the natural round outside surface of the tree under the bark) on an angle brace between two joists (See figure: 9). From this, it can be stated that, although predominantly heartwood, certainly the

subfloor framing also comprises a small proportion of untreated tōtara sapwood. Importantly, no evidence of borer (or other defects) was observed in these pieces of timber. Therefore, these examples demonstrate excellent structural service from untreated tōtara timber, including from some pieces that contain a portion of untreated tōtara sapwood.

Figures: 6 & 7- Untreated tōtara subfloor framing of houses built in 1953 & 1962. No evidence of borer was observed. N.B. – the distinct colour variation on the same piece of timber (– notably the angled brace in the right-hand image) presumably indicates a transition zone from heartwood to sapwood timber.

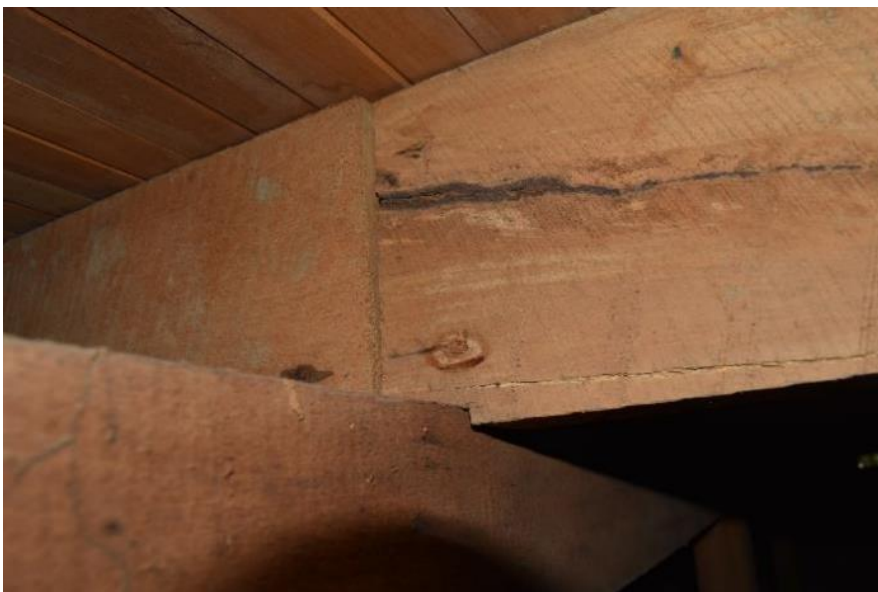
Figure: 8 – Bark encasement on one of the timber joists is presumably associated with a portion of sapwood content on this piece of timber. No evidence of borer was observed.

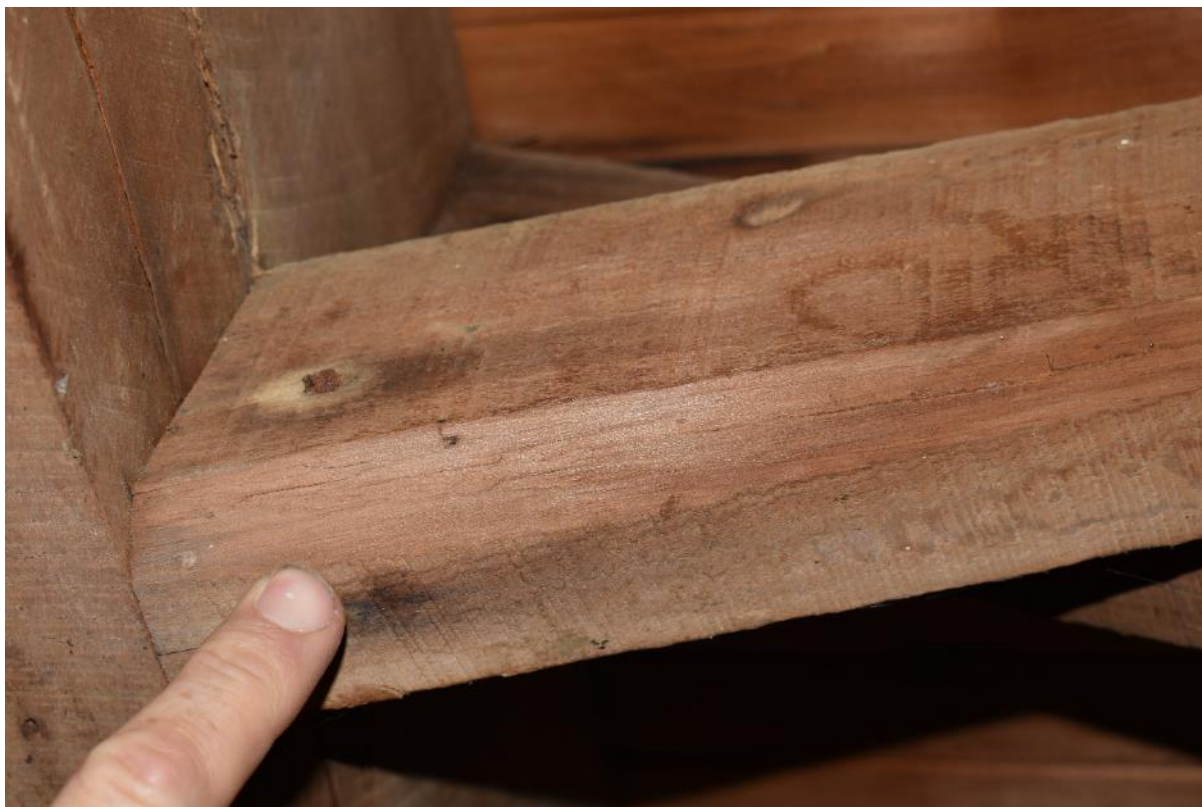
Figure: 9 – Obvious incidence of wane indicates the definite presence of sapwood on this piece of timber (in service since 1953). No evidence of borer was observed.

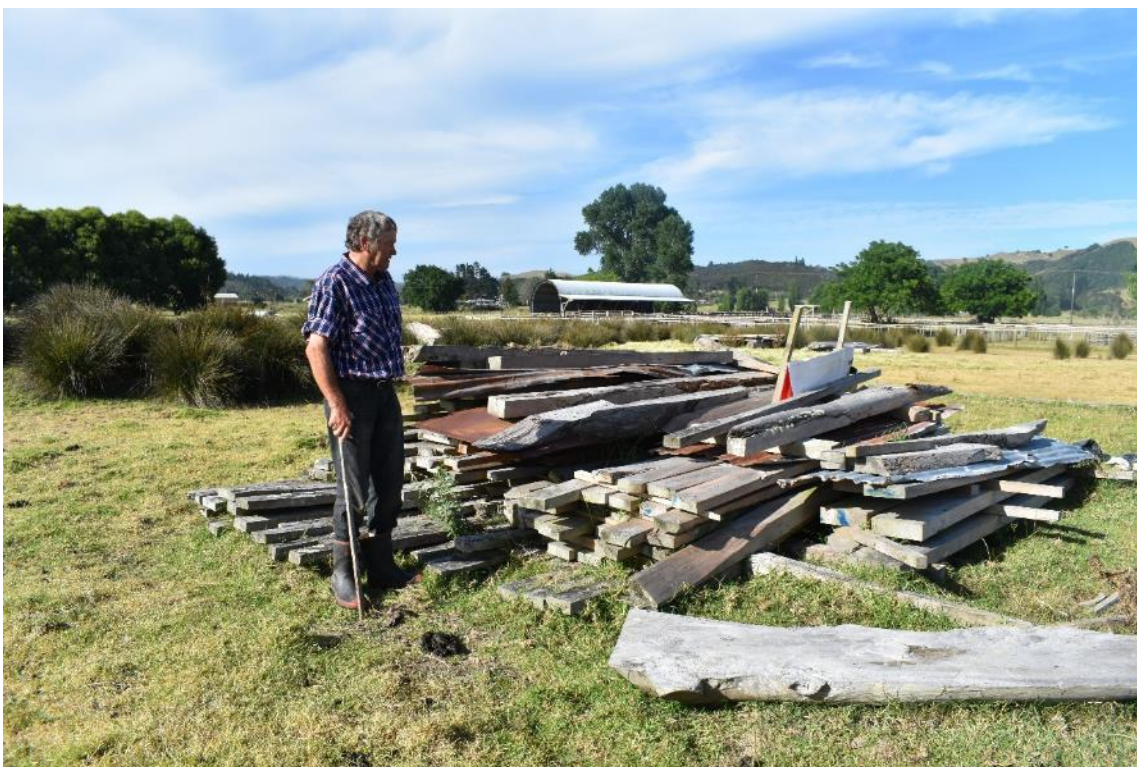
Figure: 10 – Michael Hayes next to a filleted stack of farm-tōtara timber in a paddock.

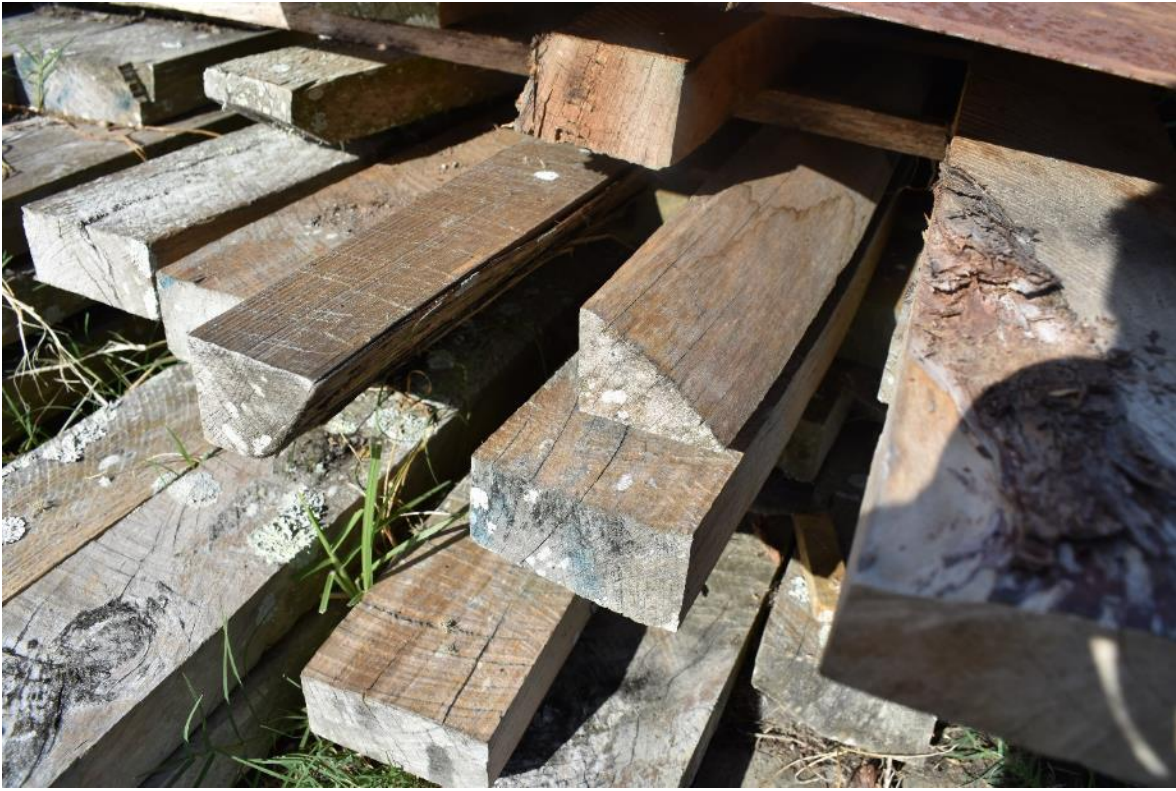
Figure: 11 – No incidence of borer was observed in the stack of untreated tōtara timber, which includes boards that clearly comprise a high proportion of sapwood timber.

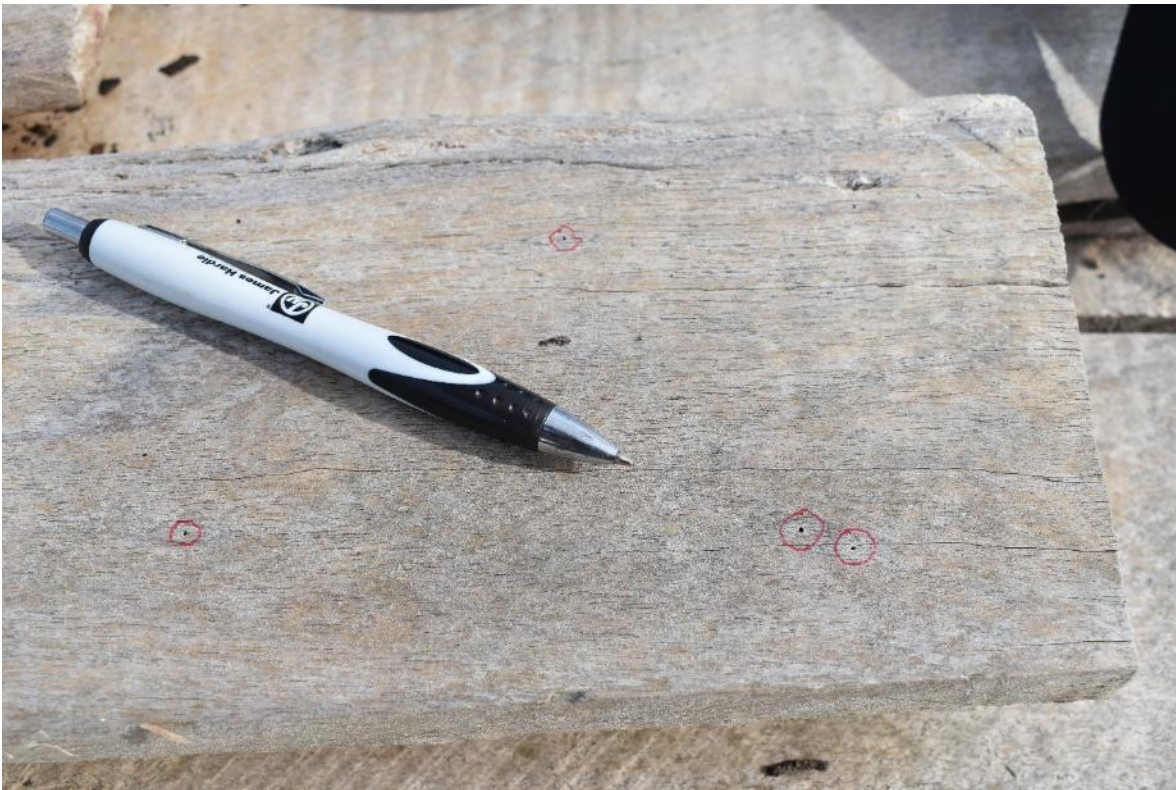
The tōtara timber has not been preservative treated. No evidence of any borer attack was observed, despite the fact that a stack of taraire timber that was milled at the same time and has been similarly stacked, less than 25 metres away, in the same paddock, shows definite signs of borer damage (See figure: 12). Even more compelling is that the taraire had been sprayed with a mixture of “Clear Metalex” (Zinc Naphthenate 60% (Zinc as metal 8%)) & thinned with mineral turpentine, but the tōtara had no such treatments applied.

Figure: 12 – In contrast to the tōtara, an adjacent stack of taraire timber, milled at the same time, has been damaged by the common household borer (*Anobium punctatum*), despite being sprayed with Clear-Metalex & Turps.

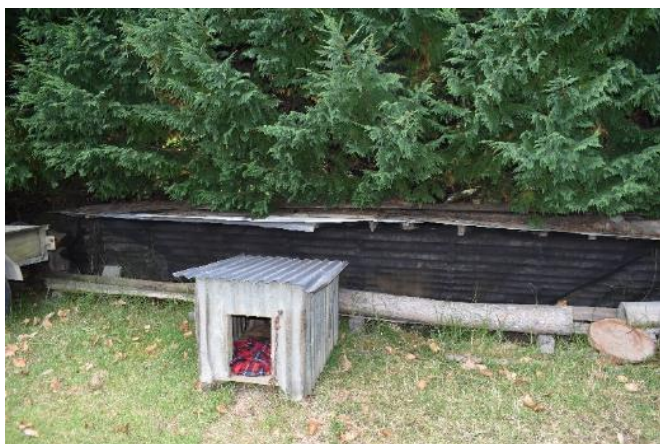
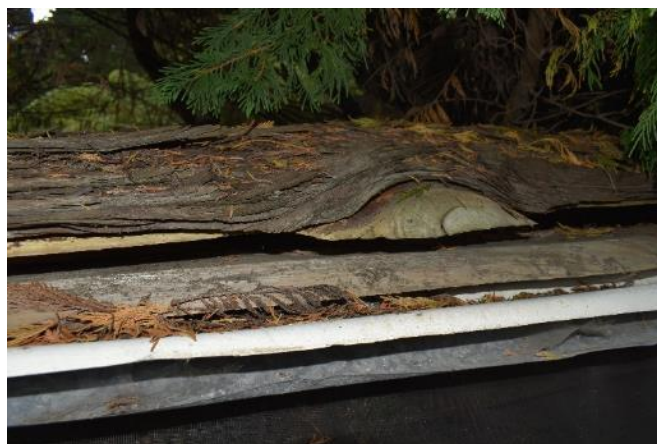
Figures: 13 & 14– Flitches from a farm-tōtara tree milled in 2008 have been used to weigh down roofing iron that covers a stack of the filleted timber stored outside under a Leyland cypress hedge for over 8 years now. No evidence of the common household borer has been observed (See figures: 15).

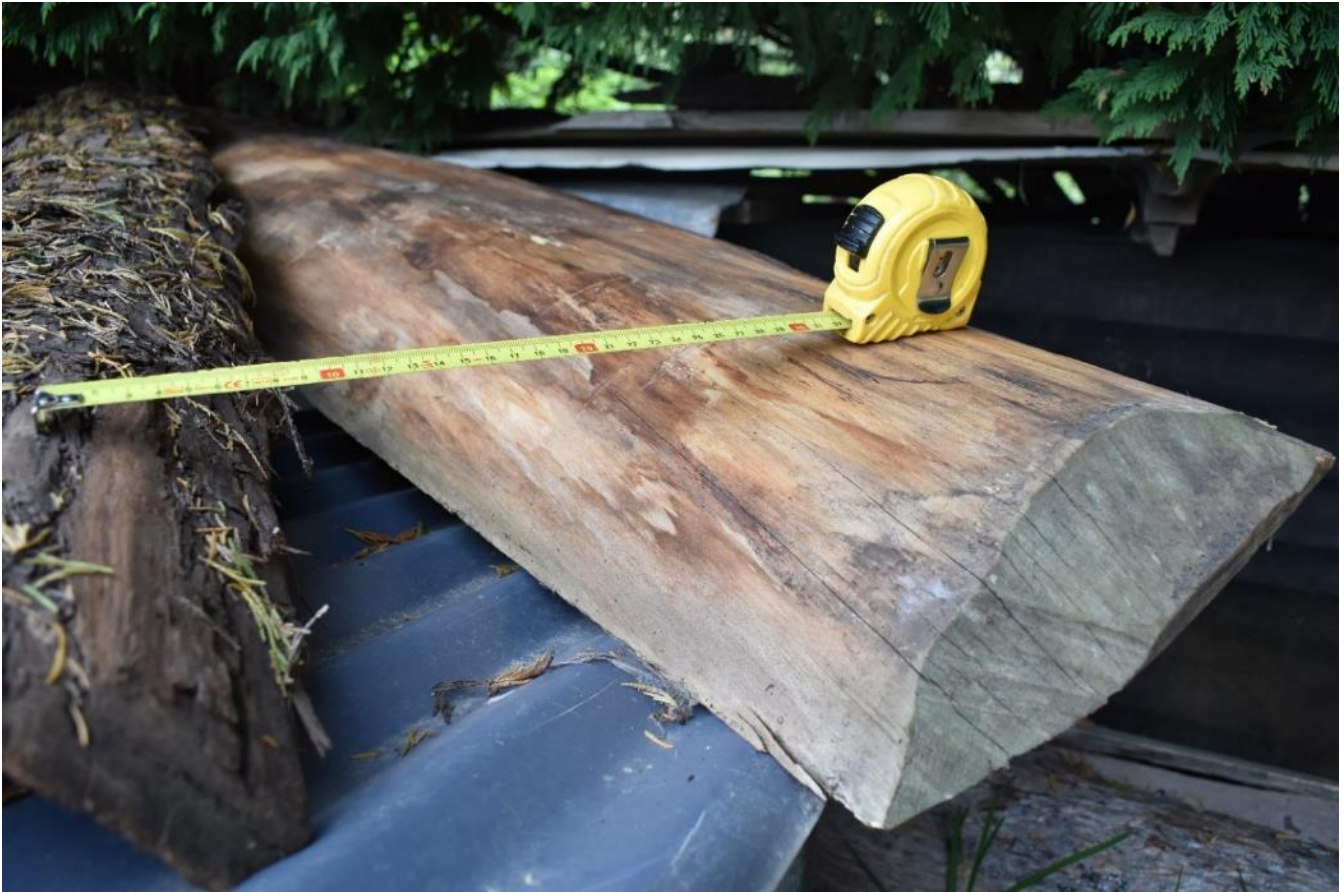
Figure: 15 – Even under the bark that had just been removed no evidence of borer damage was observed on the sapwood timber of the flitches that have been stored outside since milled in 2008 (i.e. over 8 years ago).

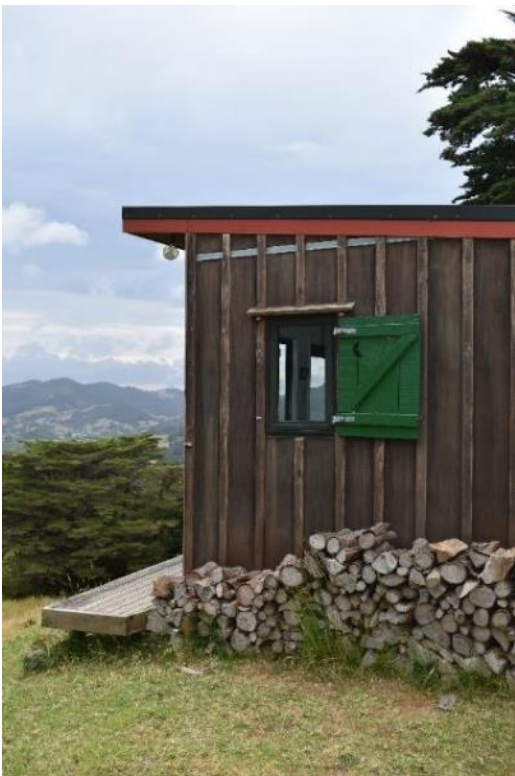
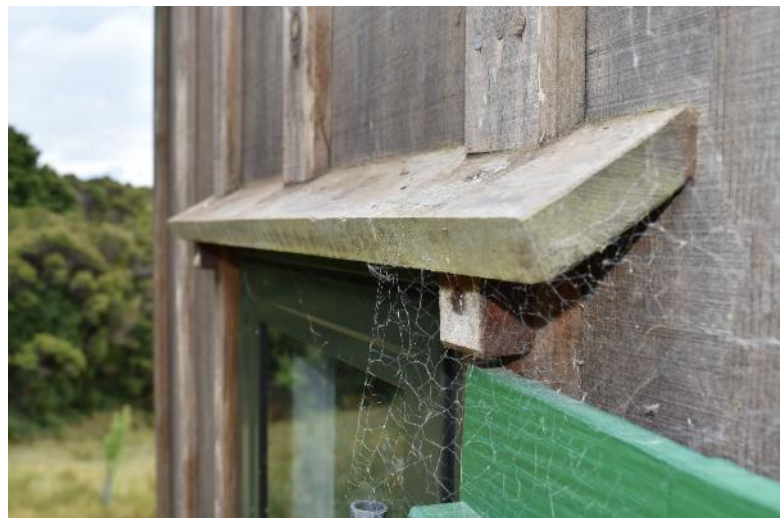
Figures: 16 & 17 – ‘Coloured’ pieces of totara timber (i.e. ones that are part sapwood/ part heartwood), were deliberately used in August 2009 as a performance trial of untreated tōtara in

exterior above ground situations. They form the weather shield hoods above the windows and door (and the support blocks). The lower drip-edges of the weather hoods comprise sapwood, the upper edges against the exterior walls are the darker heartwood. The colour transition is faintly visible on the end-grain in the above photograph. The interface with the wall was filled with clear silicone sealer and the timber painted liberally with two coats of a timber preservative oil (Red ENZ, Natural Timber Finish and Preservative). The three weather hoods are still in good condition now after more than 7 years' service without any maintenance or recoating.

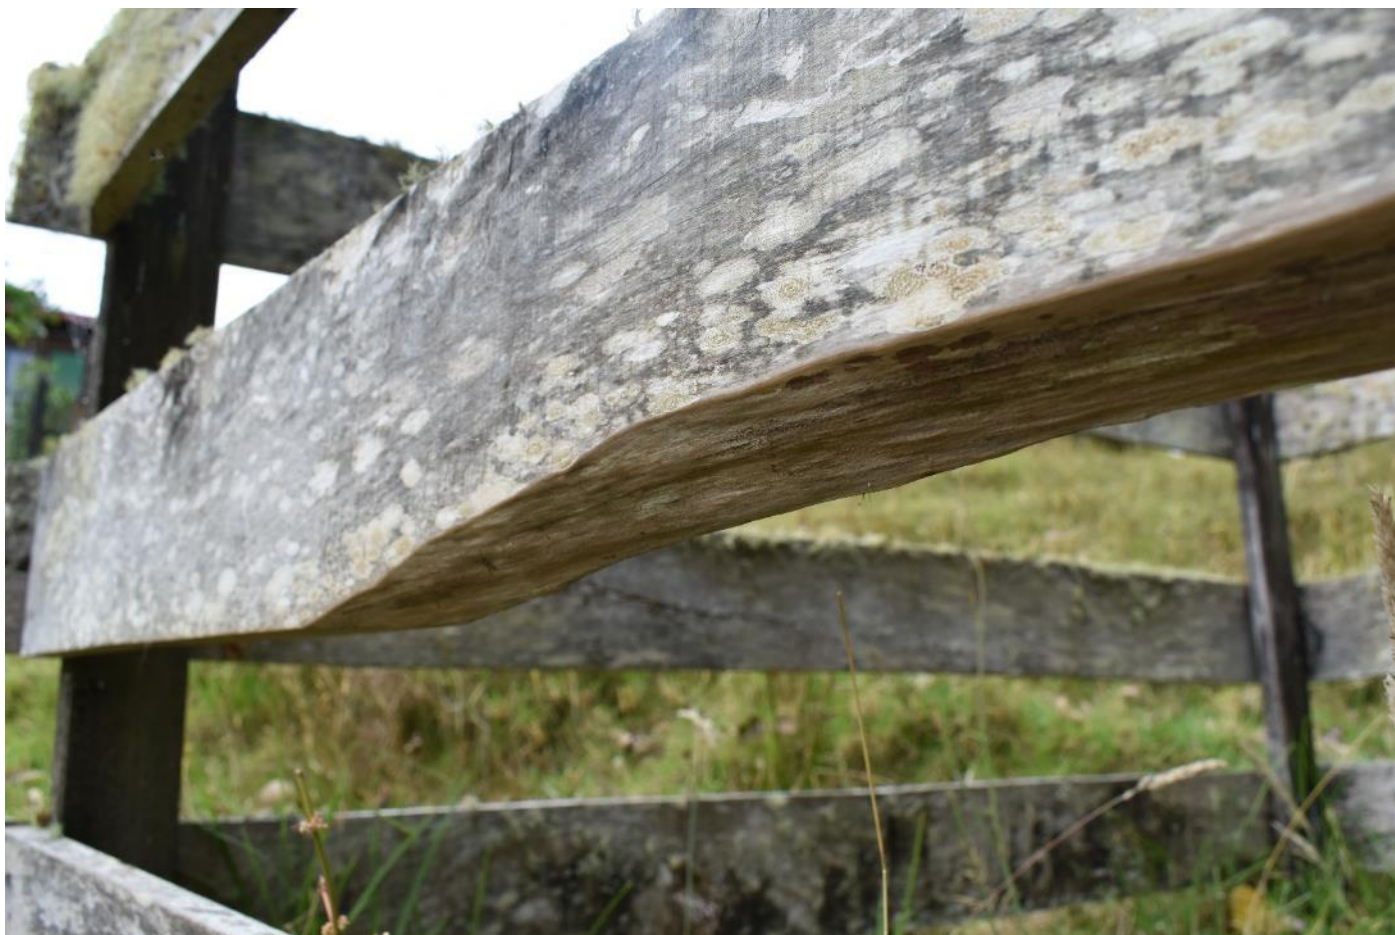
Figure: 18 – Untreated tōtara timber rails milled in 2008 and used in service outside since 2009 (i.e. 7 years so far). N.B. - many boards have wane and will therefore include a portion of sapwood. Although not expected to be durable in this exposed exterior application, no evidence of borer or rot/deterioration is yet evident.

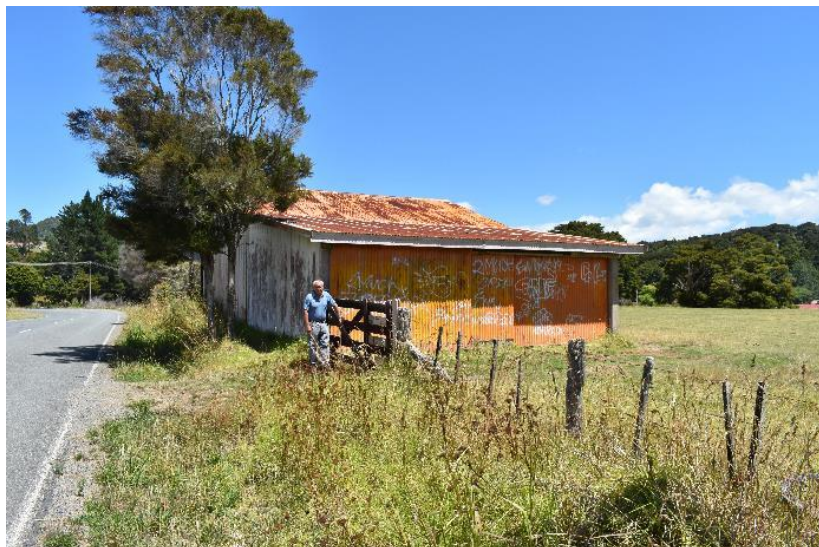
Figure: 19 - John McGee stands by a 'lean-to' addition to a shed on Robert Hayes' property on Omaunu Road in Kaeo. In 1968 John and the (late) former owner, Jim Leslie, cut and delivered two tōtara trees for use as beams in the lean-to construction.

The final examples demonstrate the structural use and performance of untreated pole tōtara (i.e. small diameter tōtara trees – down to 160mm small end diameter).

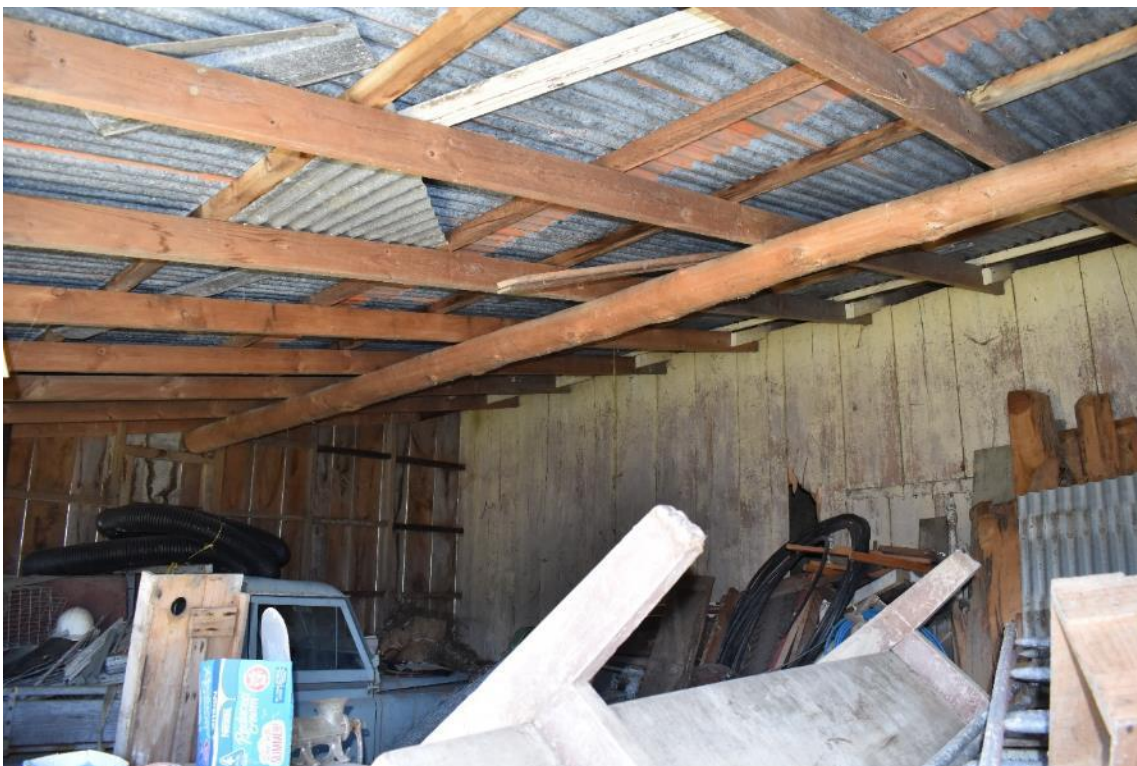
The tōtara trees were cut and used green. John cut the branches flush with an axe and the bark and was removed. The beams have been partly square-sided with the skilful use of an axe (John think's Bill Bramley did that), but for much of the length the natural round of the tree's wood immediately under the bark remains. This natural round surface, and just under, is certainly sapwood. One beam forms the lintel above the doors and the other supports the roof rafters under the mid-point of their spans. The tōtara beams are 8.57metres long and span at least 8.37m. The lintel has other boards fixed to it therefore its diameter could not be accurately measured although the natural round surfaces indicate that it was clearly a relatively small diameter tree. In contrast, the tōtara support beam located under the mid-span of the rafters, is fully exposed and could be more accurately measured, although the rough 'squaring' of two faces of the last 2metres near the larger end, means that the large end diameter could only be estimated (at 30cm), based on the remaining half to two-thirds of the natural round of the tree. The small end diameter was accurately measured at 160mm.

Figure: 21 The 8.57m long beam (under the rafters) has provided the mid-span rafter support since Oct. 1968, is an untreated tōtara pole, mostly still in the round form, but partly flat-sided (by axe) on top and near the butt end. The small end diameter is 160mm and the large end diameter is estimated at <30cm. The beam had the bark removed and was used green. Although borer is present in other timbers in the shed, no borer attack was observed at all in this (or the other) tōtara beam.

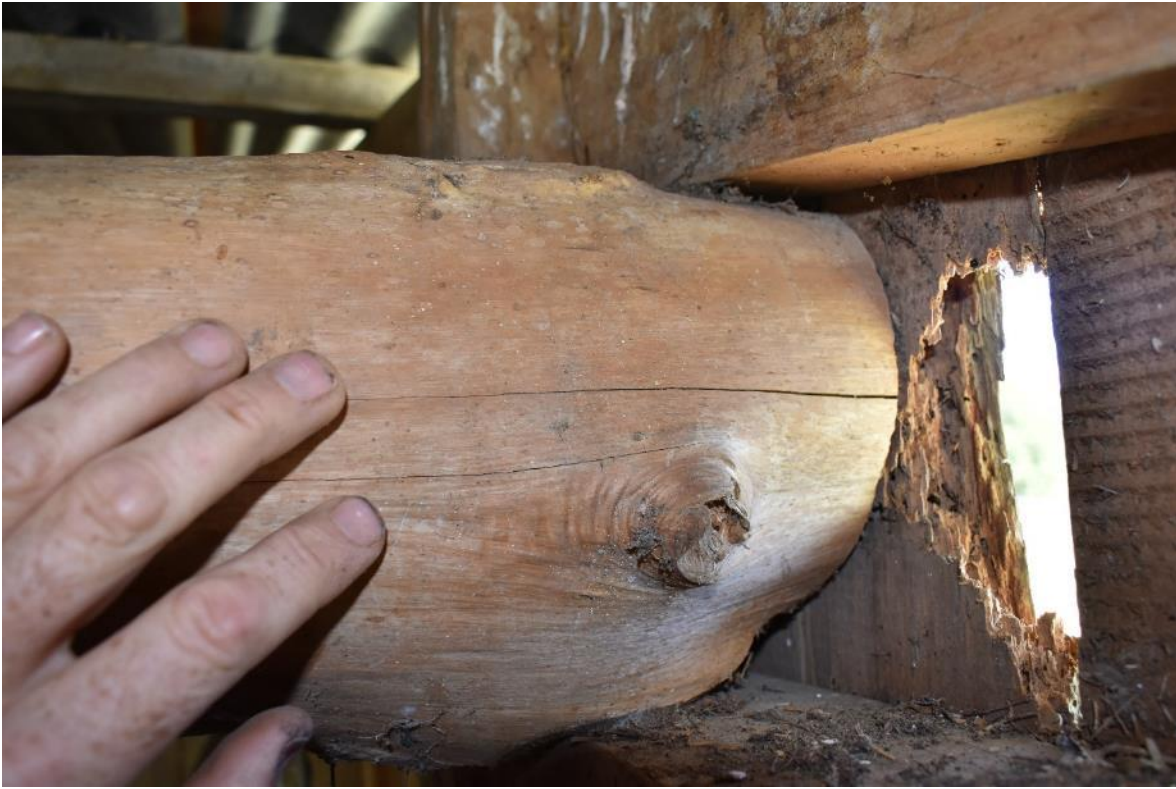
Figure: 21 – The small end of the beam has a diameter of 160mm and immediately abuts a rotting board of the exterior cladding. No borer or rot is evident in any part of the untreated tōtara beam. It has been in services for over 48 years.

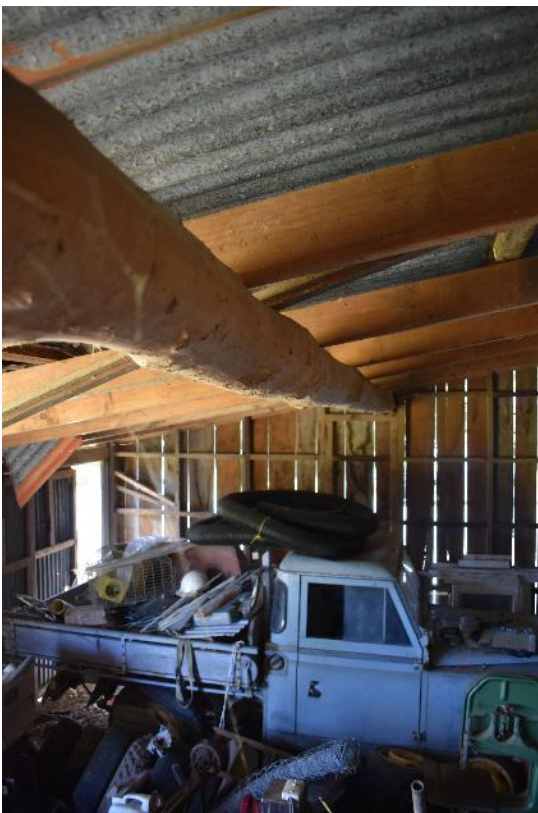
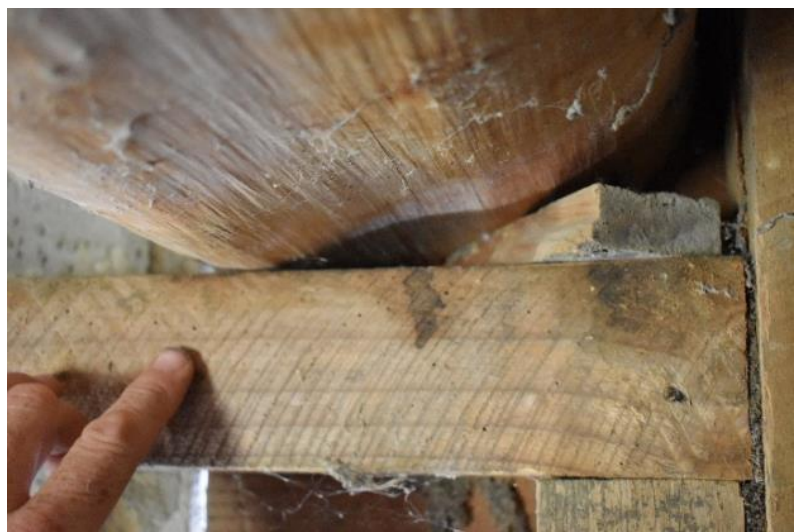
The rest of the shed addition is made from various timbers that appear to be mostly kauri. Amongst the items stored in the shed, are some kauri slabs. Robert Hayes says the sapwood of the kauri has some borer damage. House borer holes were also observed in the nogs of the framing (thought to be kauri sapwood), directly on top of which the large end of the mid rafter tōtara beam rests (See figure: 23).

Figures: 22 & 23 – View to the large (butt) end of the 8.57m long tōtara beam, which rests on a piece of framing timber with house borer exit holes. However, no borer or rot is evident in any part of the untreated tōtara beam (N.B. the smooth natural round surface of the timber under the bark).
